Mazda 3, 6 and CX-5 equipped  
with the 2.2 diesel engine

## Exhaust Pressure Sensor

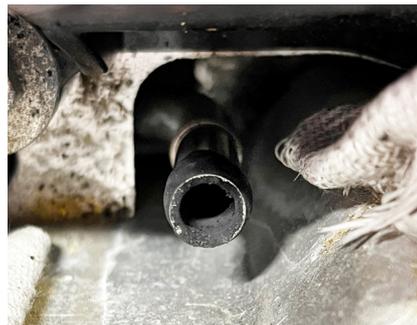
Fig. 4

However, the metal pipe from the exhaust to the sensor is susceptible to becoming blocked with carbon deposits. Therefore, before replacing the sensor, check that the pipe is not blocked. febi replacement Exhaust Pressure Sensor 194893 follows the current updated design from the vehicle manufacturer.

Unplug the original sensor from the wiring harness and discard. Remove the original rubber hose from the metal pipe and check for carbon deposits. (Fig. 4)
