febi 39888, 39890, 45931, 102278, 1003245

To fit:
Volkswagen Transporter T5

Insert shaft

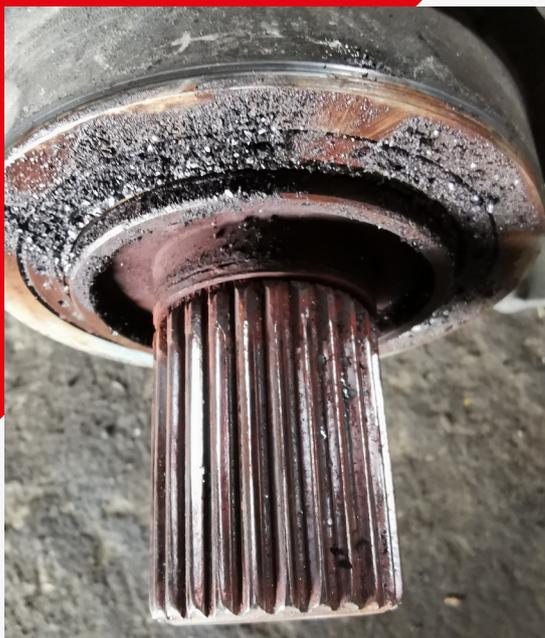
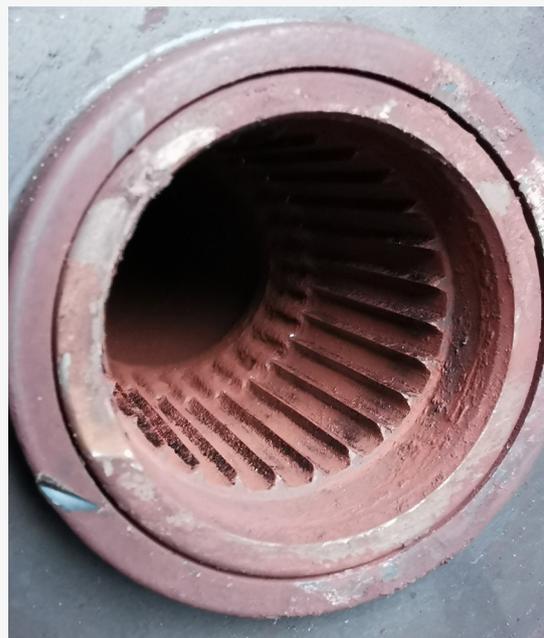
The clonking noise - or loss of drive - is due to the excess wear between the connecting splines of the right insert shaft and the driveshaft. With the vehicle raised, inspect the area of the right-hand driveshaft. Rust stains can usually be found between the insert shaft and the driveshaft due to a lack of lubrication. As a result, the splines of the shafts will have become very worn and will no longer mesh together to drive the wheel.

Example pictures below of the worn driveshaft and insert shaft.

Drain the transmission oil and remove the right-hand front wheel. Remove the worn driveshaft and inspect.

Using a suitable counter hold tool - to stop the insert shaft from turning - loosen the retaining bolt.

Remove the insert shaft from the transmission and inspect for any broken parts (Note: it is common for the brass ring to fracture causing remains to be left inside the differential). Remove all broken metal fragments, as necessary, then remove the driveshaft oil seal.

Apply a high temperature multi-purpose EP grease (21909) to the new seal, filling the space between the sealing lips before installing. Once installed, insert the new insert shaft into the transmission and tighten the retaining bolt to 25 Nm (5-Speed 02Z Transmission) or 35 Nm (6-Speed 0A5 Transmission) using a suitable counter hold tool.

Apply a high temperature multi-purpose EP grease to the mating surfaces of the insert shaft and driveshaft. Then install the new driveshaft assembly and tighten all fixings to the manufacturer's recommended tightening settings.
