Mazda 3, 6 and CX-5 equipped  
with the 2.2 diesel engine

## Exhaust Pressure Sensor

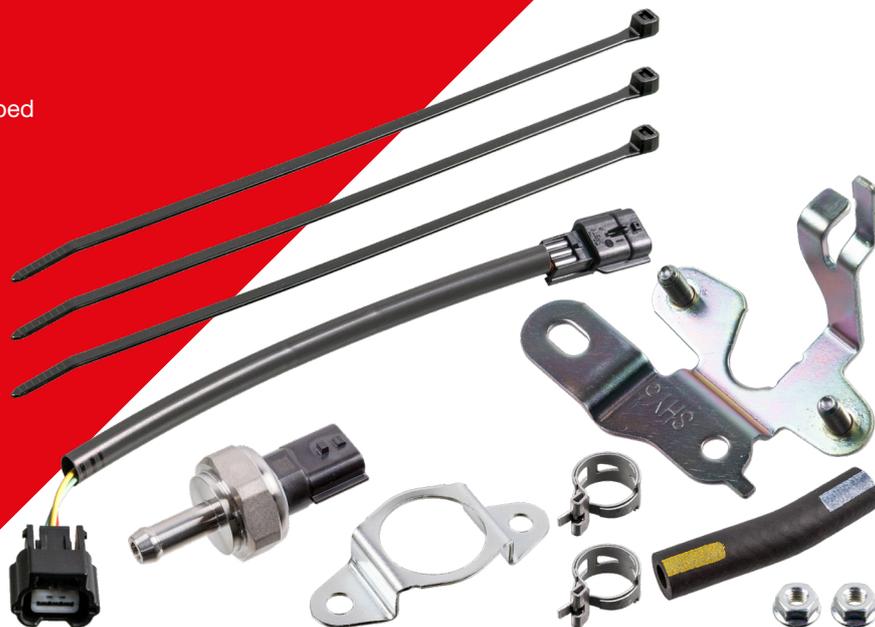
Exhaust pressure sensor is faulty, or the pipe from the exhaust to the sensor is blocked with carbon deposits.

To replace the sensor, first remove the plastic engine cover, then unplug the electrical connectors to some of the injectors so that it is easier to gain access to the exhaust pressure sensor. (Fig. 1)
