febi 39888, 39890, 45931, 102278, 1003245

To fit:
Volkswagen Transporter T5

Insert shaft

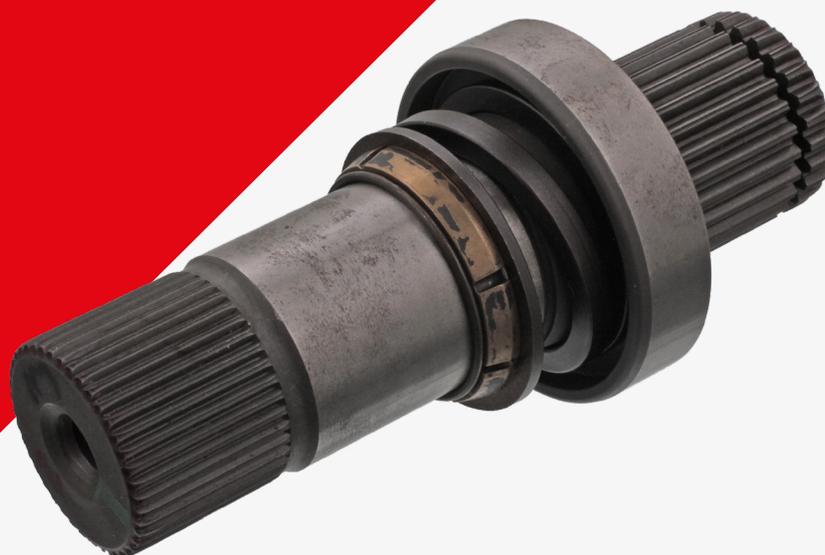
Clonking noise when pulling away or complete loss of drive.

The clonking noise - or loss of drive - is due to the excess wear between the connecting splines of the right insert shaft and the driveshaft. With the vehicle raised, inspect the area of the right-hand driveshaft. Rust stains can usually be found between the insert shaft and the driveshaft due to a lack of lubrication. As a result, the splines of the shafts will have become very worn and will no longer mesh together to drive the wheel.

In addition, the grease applied to the joint - when the vehicle was first manufactured - can leak or dry out over time. Failure could have also been caused during the removal and repair of the transmission if fresh grease had not been applied to the connecting splines during reinstallation e.g. during a clutch replacement.

Drain the transmission oil and remove the right-hand front wheel. Remove the worn driveshaft and inspect.

Using a suitable counter hold tool - to stop the insert shaft from turning - loosen the retaining bolt.

Remove the insert shaft from the transmission and inspect for any broken parts (Note: it is common for the brass ring to fracture causing remains to be left inside the differential). Remove all broken metal fragments, as necessary, then remove the driveshaft oil seal.

Apply a high temperature multi-purpose EP grease to the mating surfaces of the insert shaft and driveshaft. Then install the new driveshaft assembly and tighten all fixings to the manufacturer's recommended tightening settings.
